PREPRODUCTION TESTS OF THE BDU-41/B PRACTICE BOMB

TECHNICAL REPORT NO. AFSWC-TR-69-8

August 1969

Robert G. Simon

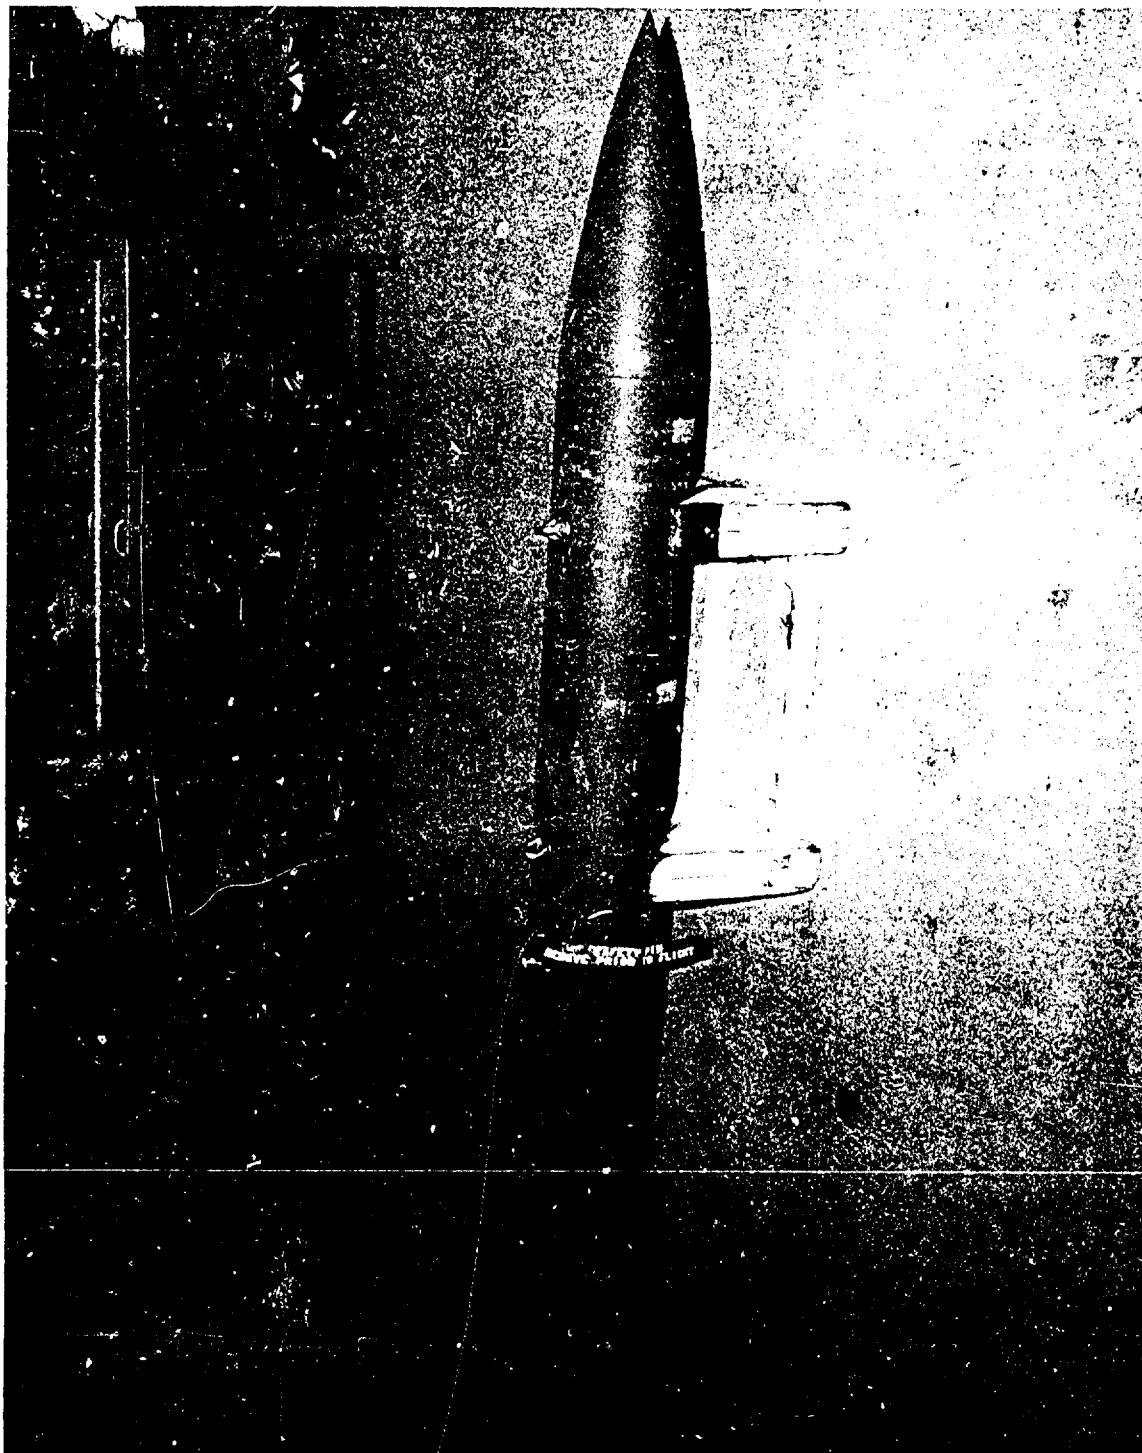
Figure 1. BDU-41/B

To determine that design of the BDU-41/B (figure 1) is satisfactory for large-scale production, the Air Force Weapons Laboratory requested the Air Force Special Weapons Center to subject a prototype BDU-41/B to measurements and tests according to the following specifications:
